Jacob's Ladder Trail Scenic Byway

Improvements Plan: Phase II

JACOB'S LADDER TRAIL SCENIC BYWAY IMPROVEMENTS PLAN: PHASE II

*Prepared by the
Pioneer Valley Planning Commission*

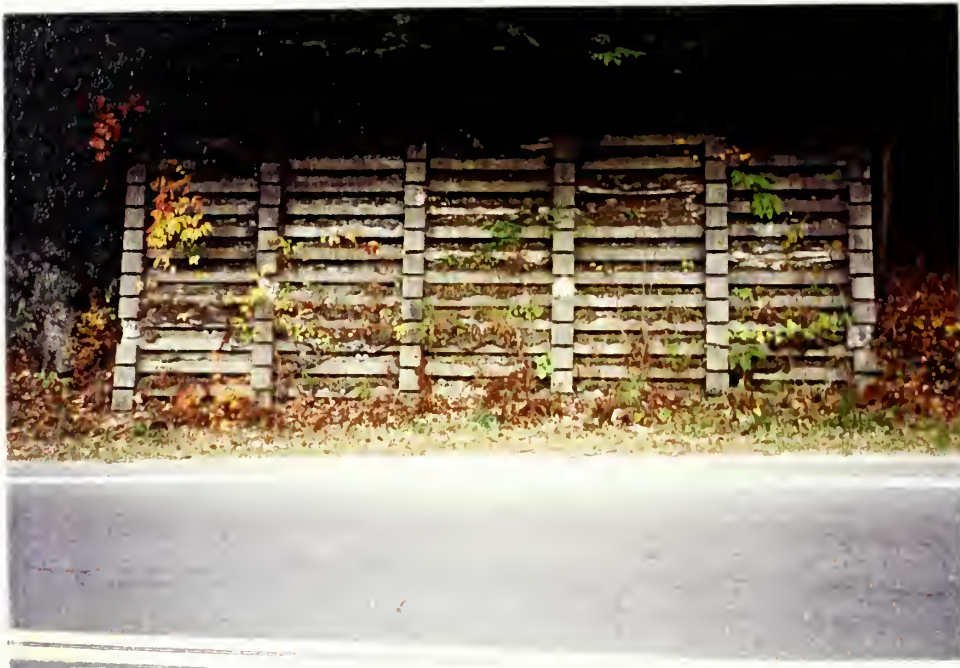
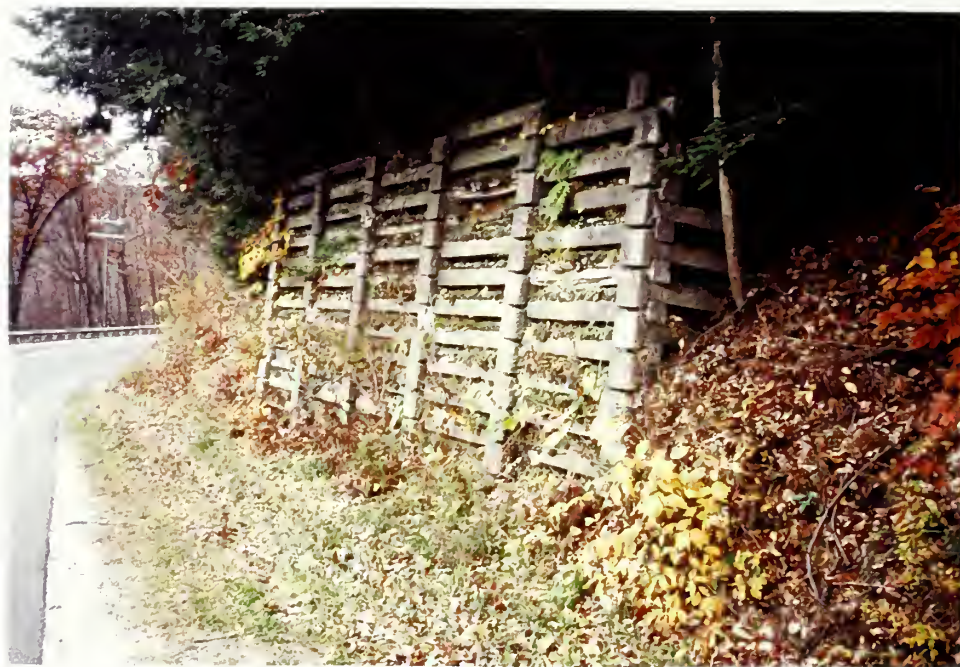
Mile Marker 43.9 Russell

Located at mile marker 43.9, this wall is approximately eleven feet high and thirty feet long. Located on the western side of Route 20, this wall appears to be in fair to poor condition. Units are stacked symmetrically and have retained their horizontal and vertical alignments. Voids in the backfill material have formed over time, as well as the growth of trees.

Several members have eroded. A potential cause is water infiltration into the members, resulting in pieces of concrete spalling off of members. It is also possible that car or truck impacts have knocked off pieces of the concrete members. There are some elements with exposed reinforcing bars. The exposed surfaces of the bars are rusted; some bars appear to be broken off completely.

At the top northeast corner, an element is missing, and its sister member appears to be loose. Exposed ledge is adjacent to the wall in the southeast side. It is within ten feet of the edge of pavement. More ledge is visible to the north of the existing wall.

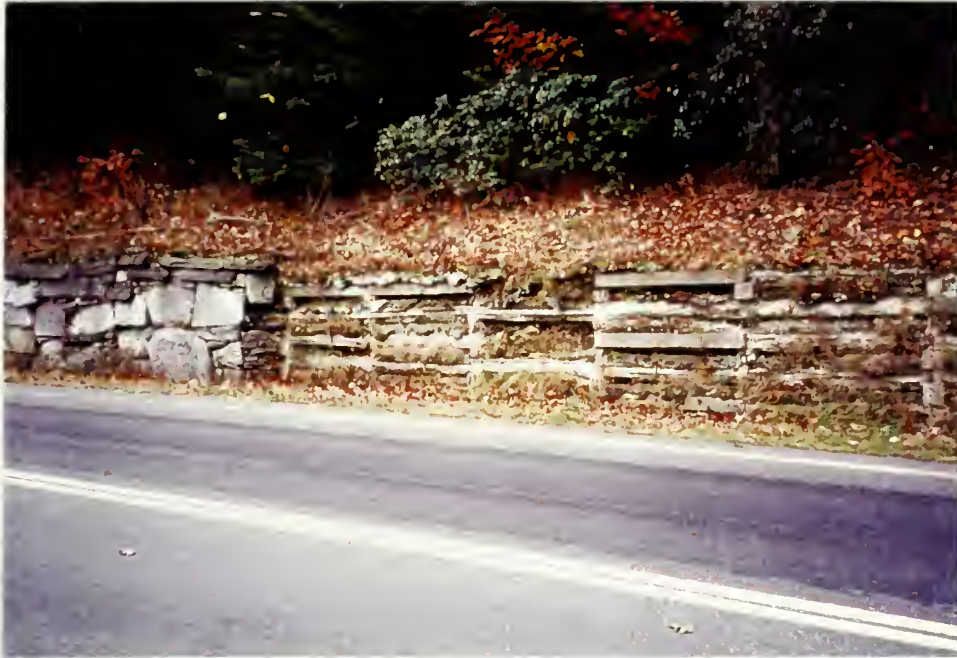
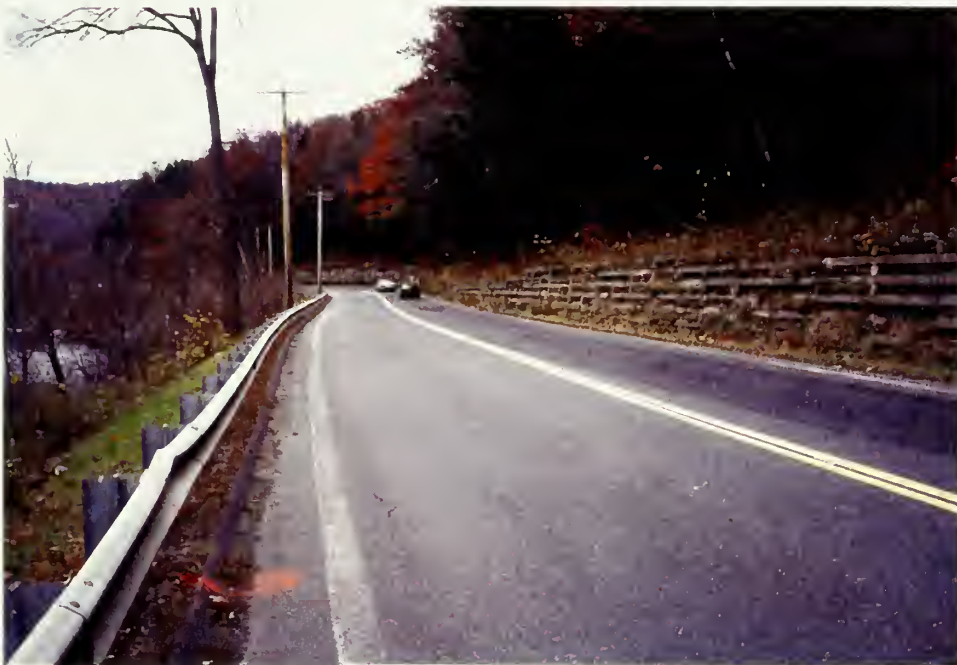
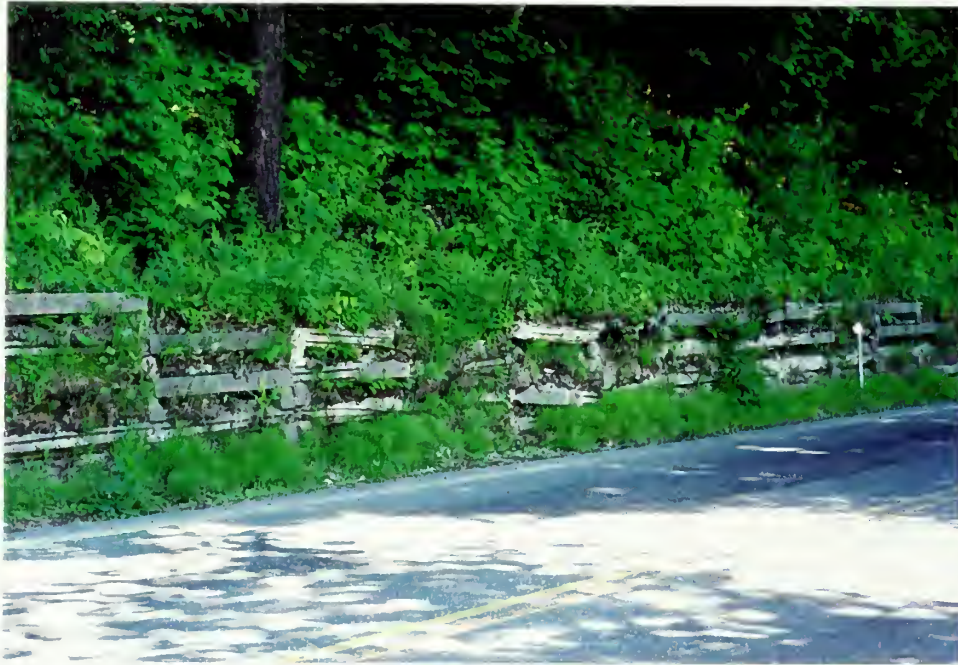
Mile Marker 43.1 Russell/Huntington

Located at mile marker 43.1, on the western side of Jacob's Ladder Trail, this concrete crib wall ranges in height from four to seven feet and is approximately 415 feet in length. It is an unsightly, dilapidated structure which is in poor condition along its entire length. On the east, this wall abuts a stone wall that is to remain. At the junction of the two walls, the concrete members of the crib wall appear to be in very poor condition. Large portions of concrete have spalled off. At the spall locations, exposed steel reinforcing is significantly rusted and there are a few broken bars. The backfill material

is nonexistent. Proceeding westerly, the wall continues in a similar state. Most exposed elements are severely deteriorated with rusted steel reinforcing bars protruding through the concrete. This has also caused staining of the concrete. One portion of the wall has experienced horizontal and vertical movement. Elements are completely crushed or broken into fragments. At the west end of the wall, the backfill material has also eroded to the degree of being nonexistent. In addition to the questionable stability of the wall, its abrupt ending is not acceptable to Massachusetts Highway Department standards.

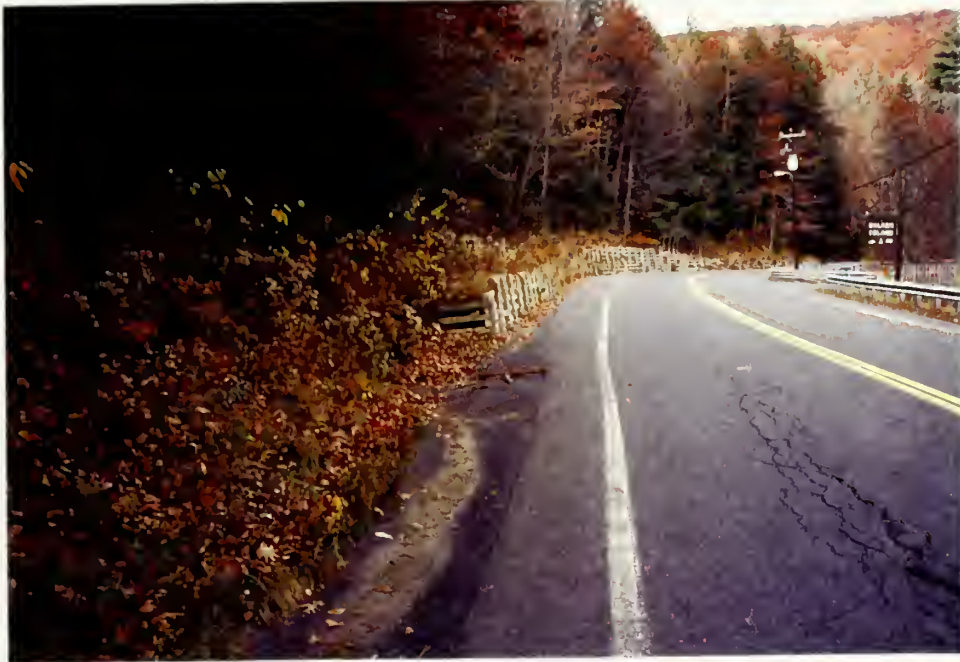
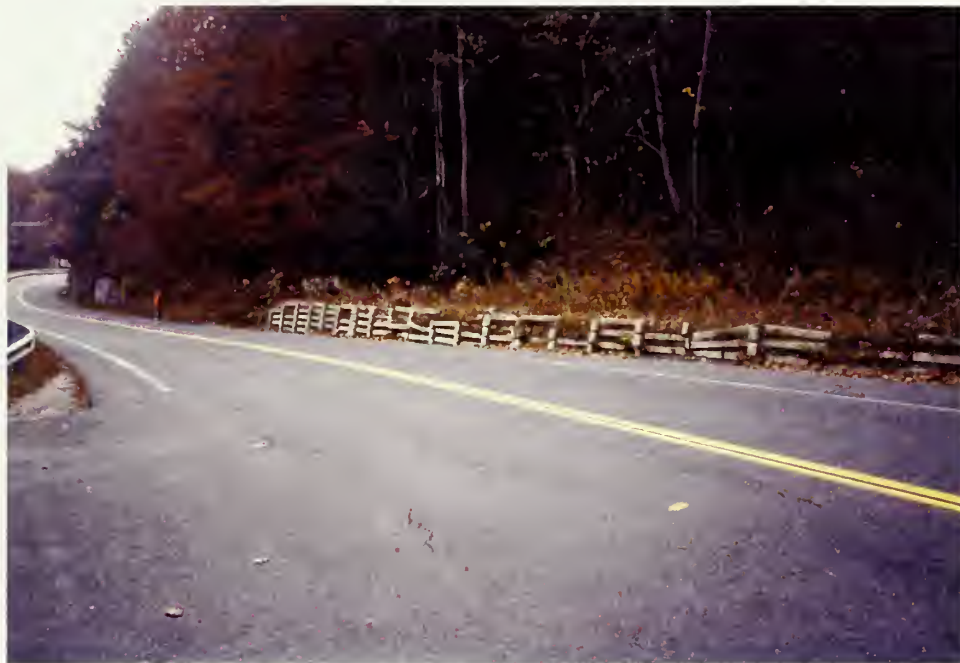
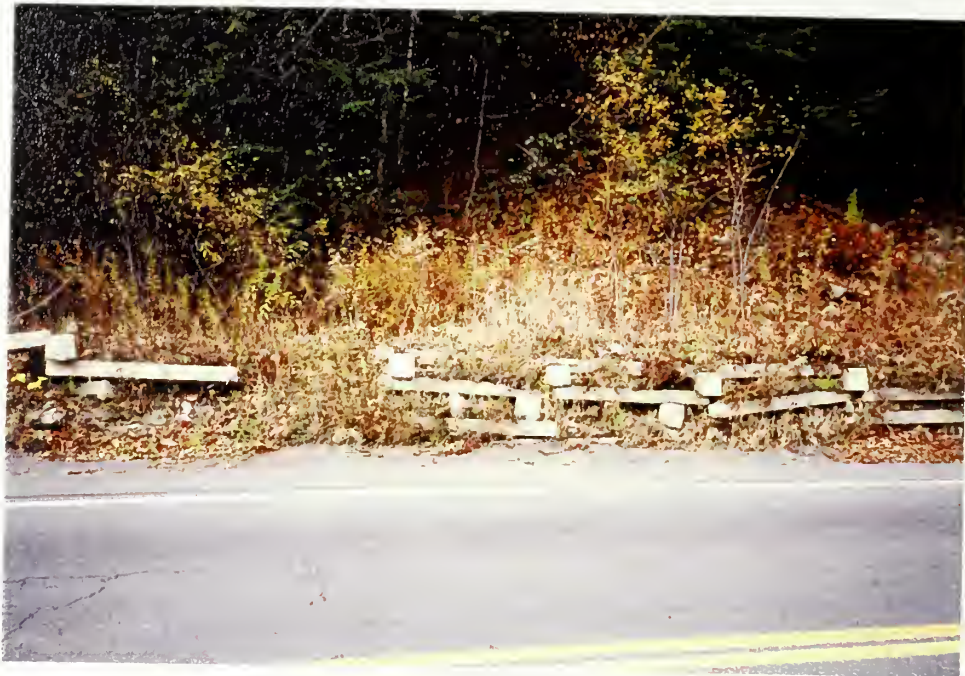
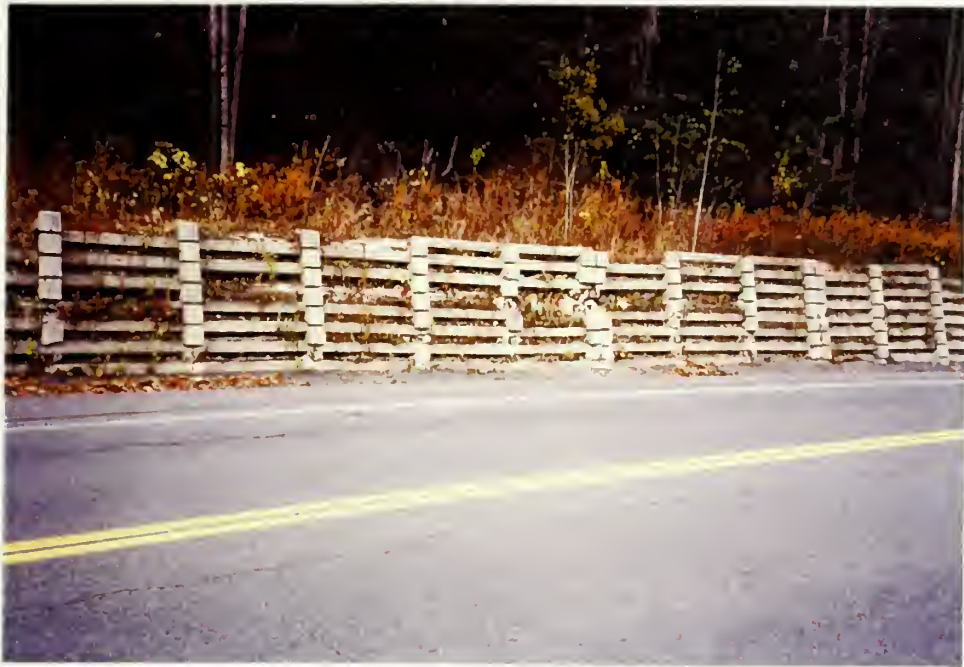
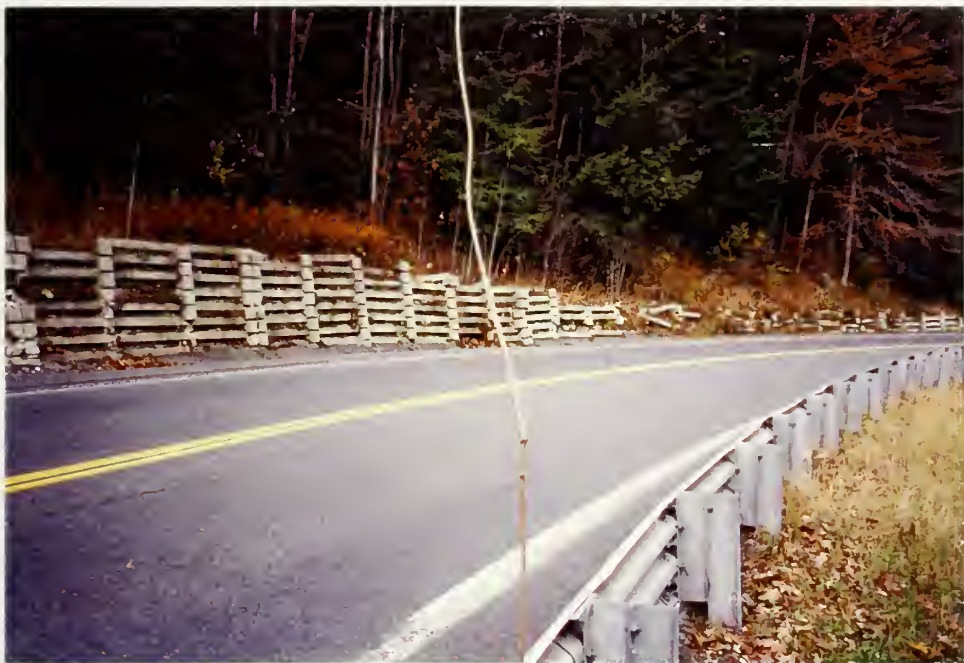
Mile Marker 34.0 Chester

Located at mile marker 34.0, on the western side of Route 20, this retaining wall is in poor condition. It ranges in height from three to seven feet and is approximately 375 feet in length. On the southerly end of the retaining wall, the entire unit is exposed on three sides. This exposure indicates that the structure is unnecessary. Rocks and boulders are present in this area. The wall has some missing elements, the majority of the members are severely deteriorated and several pieces are cracked and broken. Portions of the members have exposed steel reinforcing bars, which are severely rusted. A few members have also rotated forward and appear to be falling. Members have collapsed, causing

horizontal and vertical movement. The surrounding landscape revealed that a swale has formed or was constructed behind the retaining wall. Because of the swale, the height of the soil behind the wall is lower than the height of the top of the wall. In effect, the top portion of the existing wall is unnecessary. Proper site work and grading would eliminate the need for a retaining wall 375 feet in length and in its place a shorter 160 foot wall where there is an area of steep slope.
